**NONDESTRUCTIVE EVALUATION OF REINFORCED CONCRETE
STRUCTURES AFFECTED BY ALKALI-SILICA REACTION AND
DELAYED ETTRINGITE FORMATION**

Thesis

Presented to the Faculty of the Graduate School of
The University of Texas at Austin
in Partial Fulfillment
of the Requirements
for the Degree of

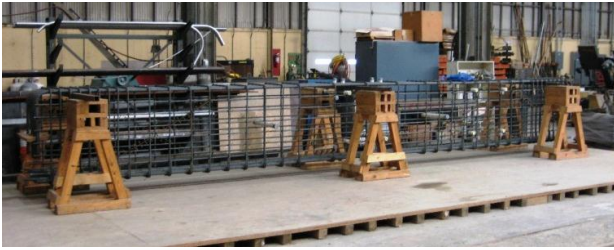
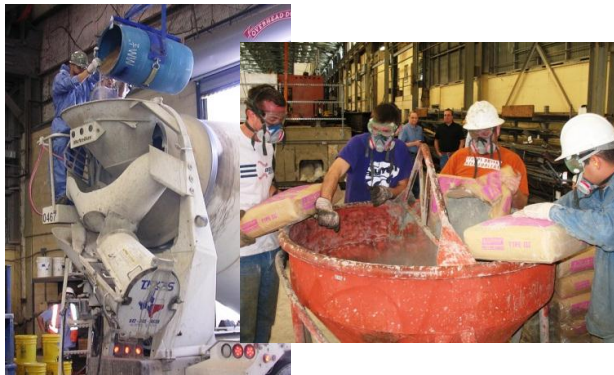
(a) Construct reinforcement cage

(b) Erect formwork, place cage inside

(c) Mix concrete

Figure 4-3: Specimen Fabrication Process

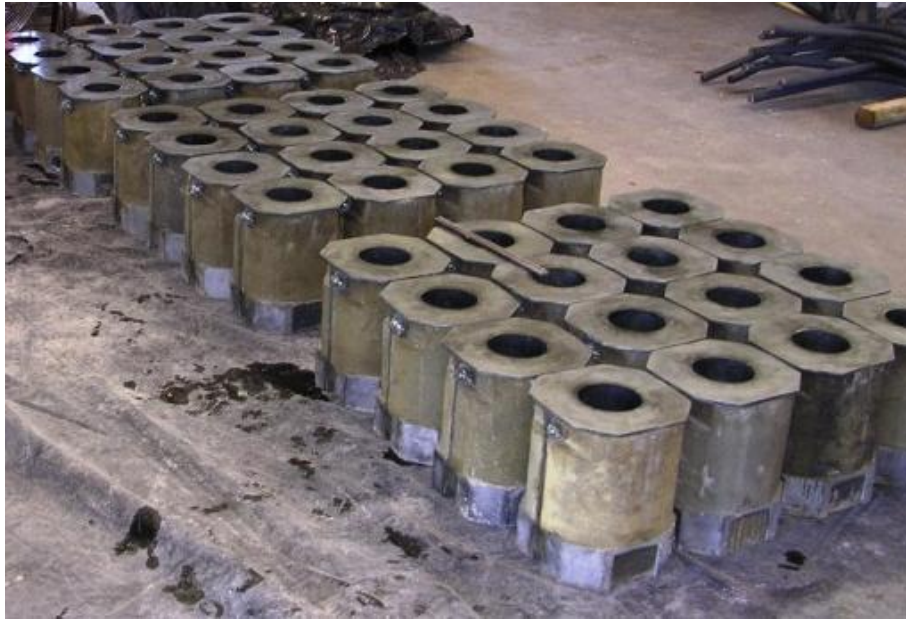
Figure 4-8: Match-Curing Cylinder Molds
